Published in:
British Journal of Cancer Research

Bleeding of the Latest Generation Silicone Breast Implants Very Shortly after Implantation

Evert van den Broek^{1,2}, Rita Kappel^{*3}

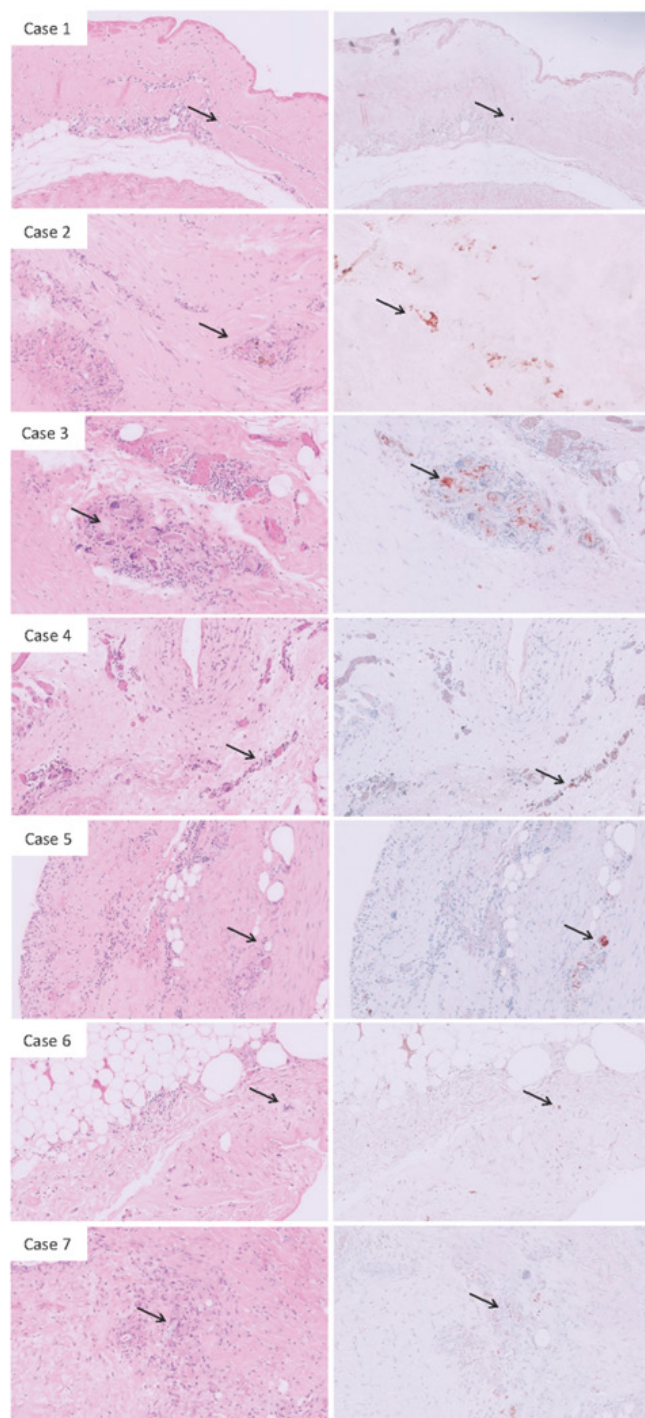
Figure 1. Representative FFPE samples of periprosthetic tissue of 7 cases stained by Hematoxylin and Eosin (left panel) and Modified Oil Red O (right panel). The images show a fibrous capsule with on the side of the breast implant, in varying degrees deposition of eosinophilic fibrinoid material. Furthermore, mononuclear histiocytic cells were seen. In all these 7 cases (A-G) macrophages with intracytoplasmic vacuoles were found containing amorph translucent material denoting deposition of silicones, indicated by arrows. Corresponding MORO-stained slides in order to confirm that this material regards to silicone depositions, show positive, mostly granular staining and were depicted in the right panel (A-G).

The phagocytized vacuoles were characterized by amorph translucent material, indicating deposition of silicone material. Evaluation of additional Modified Oil Red O (MORO) stained slides confirmed the presence of silicone material in the vacuolated cytoplasm of these macrophages [16], since it stained positive in all seven cases. Representative images of HE and corresponding MORO slides are shown in figure 1.
